REPORT NUMBER: WI/FEP-10-03

**EVALUATION OF THE CONSTRUCTABILITY
& PERFORMANCE OF MICRO-SILICA MODIFIED
CONCRETE BRIDGE DECK OVERLAYS**

FINAL REPORT

The two structures included in this study are located on STH 50 between I-94 and 43rd Avenue in Kenosha County, Wisconsin. Micro-silica modified concrete overlays were placed on Structures B-30-35, East Bound and B-30-36, West Bound (*See Figure 1 in Appendix A, page 16*).

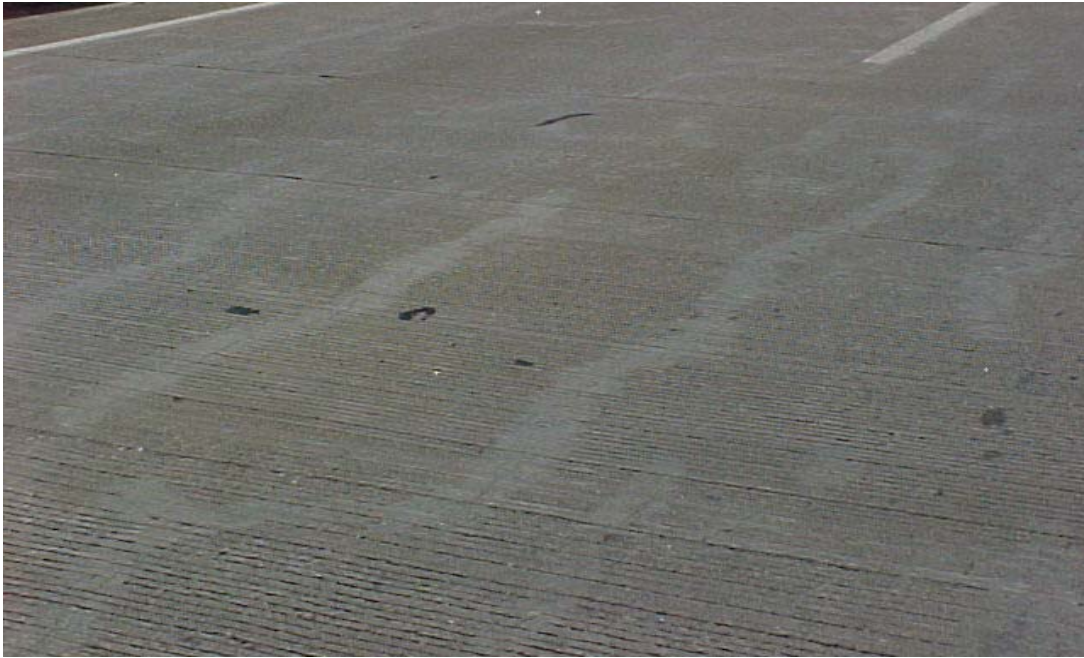
The underside of the deck showed several full depth longitudinal and horizontal cracks scattered throughout the bottom of the deck. Delamination was also present along some of these cracks. The wearing surface had longitudinal and horizontal cracks (random) throughout the bridge deck, ranging in length between two to ten feet. The density and lengths of the cracks had

Picture of deck showing some cracking (B-30-35)

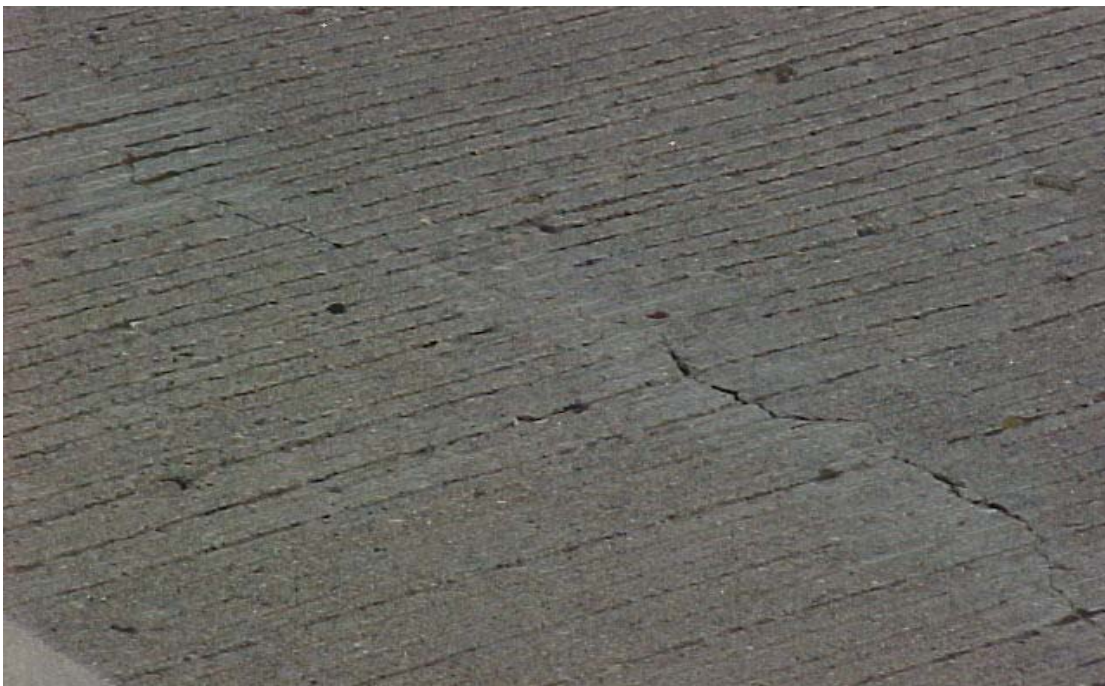
Picture of bridge deck crack (B-30-35)

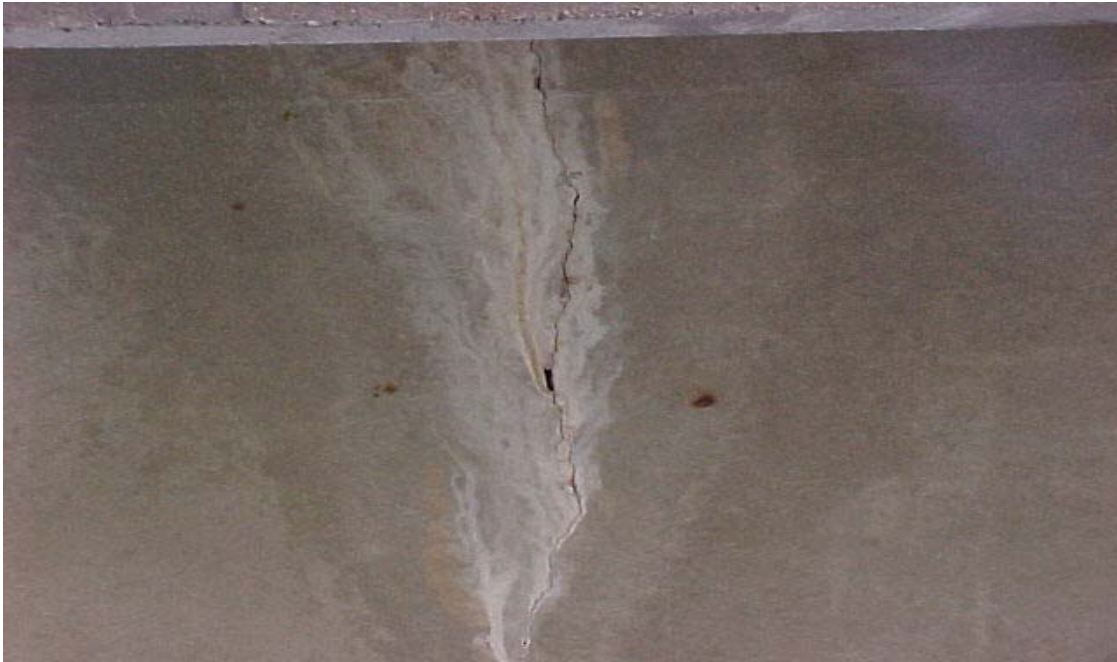
Picture of the bottom of structure (B-30-35) showing crack and efflorescence

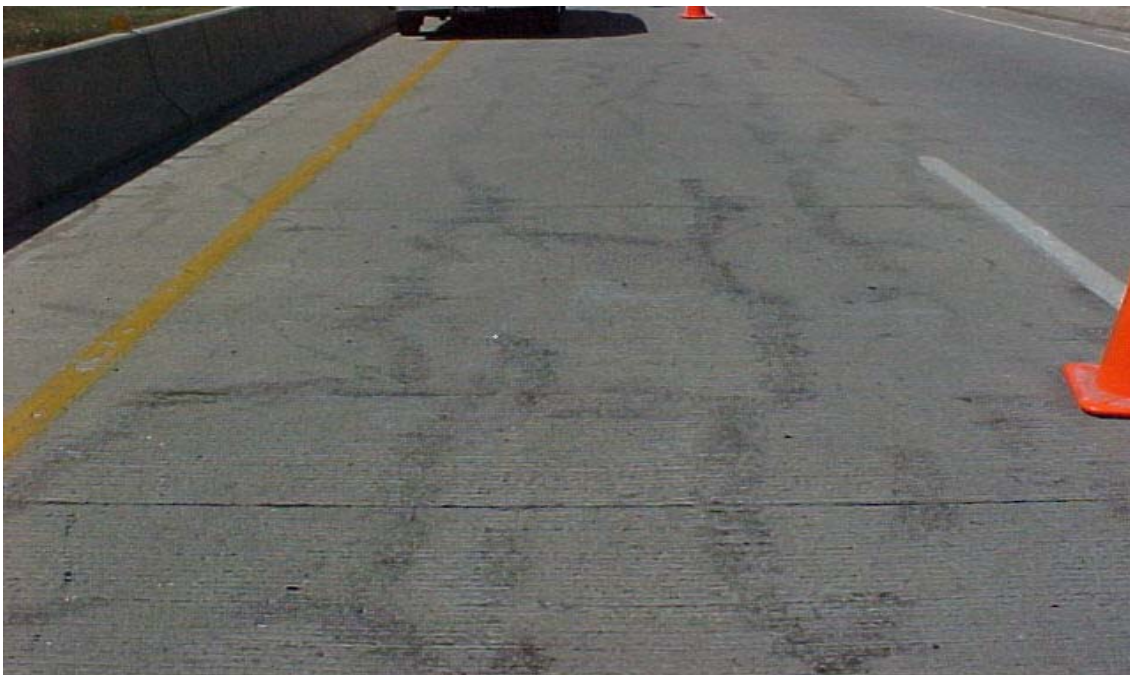
The underside of the deck showed several full depth longitudinal and transverse cracks; delamination was also present along some of these cracks. The wearing surface had longitudinal and transverse cracks (random) throughout the bridge deck, ranging in length between two and ten feet. The density and lengths of the wearing surface cracks had increased since 1997 inspection as shown in Table 1. As shown in Table 1 the total defective area had increased drastically since the 1997 inspection and nearly doubled since the 1999 inspection.

Random cracks throughout the bridge wearing surface (B-30-36)

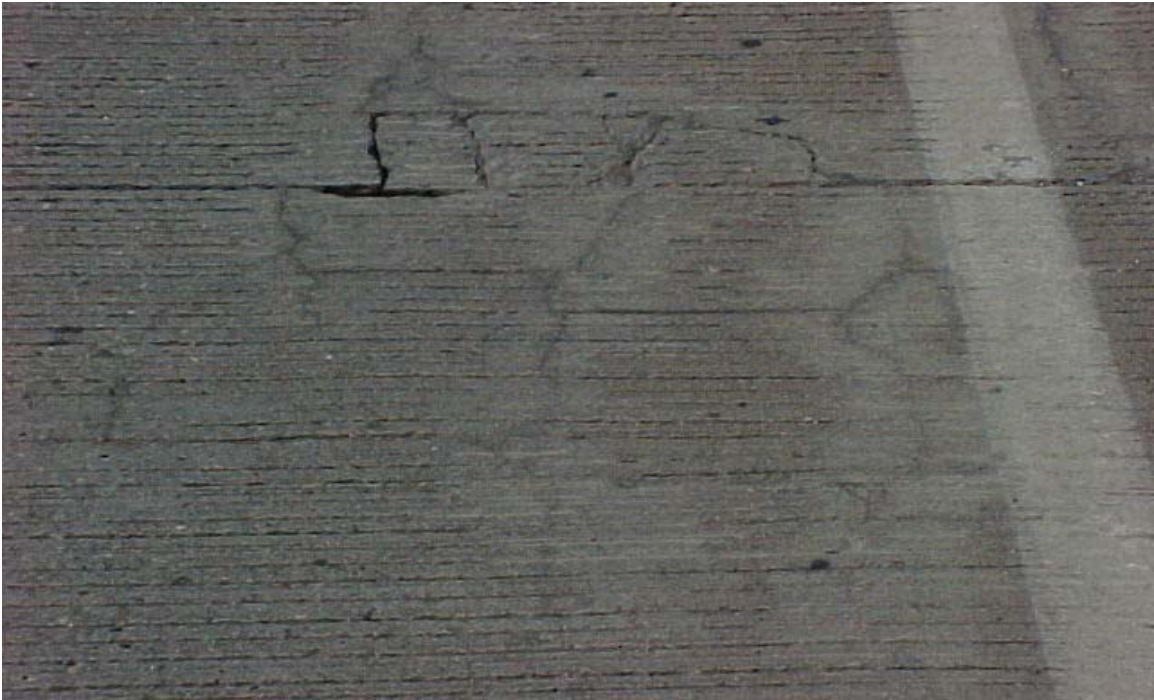
Cracks & spalling in the wearing surface (B-30-36)

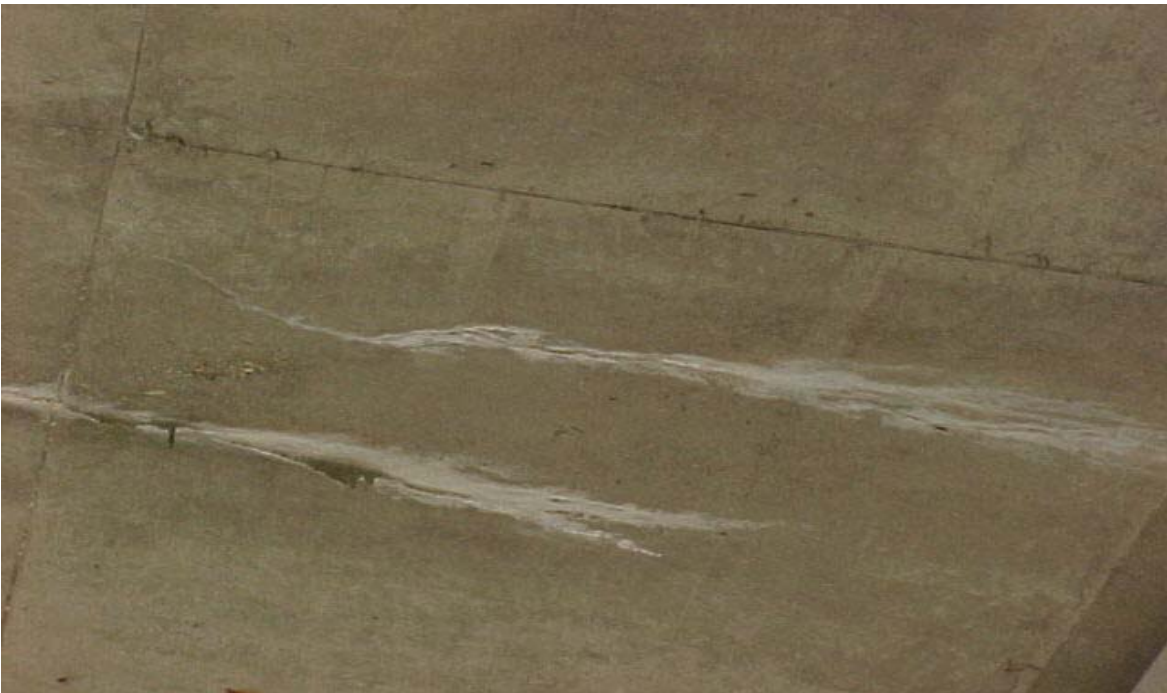
Cracks & efflorescence in the bottom of the deck (B-30-36)

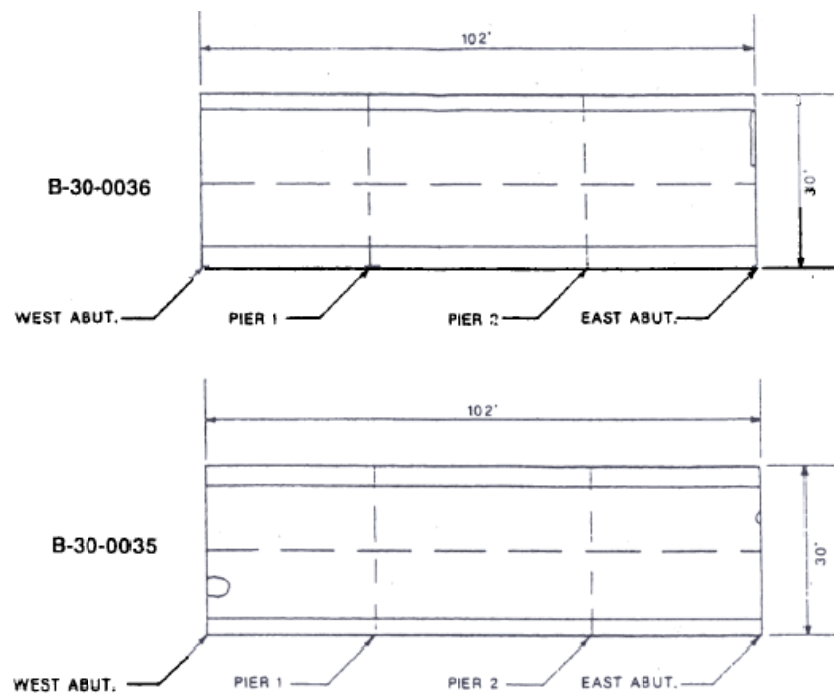
INSPECTION DATE: 6/1990

The results showed that both structures had minor defects during the first year of service, after the application of the micro-silica overlay (*See Table 1 & Appendix D*).

ST. NO. B-30-0035		ST. NO. B-30-0036	
DESCRIPTION	QUANTITY 150, FT. 1	%	QUANTITY 150, FT. 1	%
TOTAL AREA	3060		3060	
SHADE/DEBRIS	0		0	
TOTAL AREA INSPECTED	3060		3060	
DELAMINATION	0	0	0	0
SPALL	0	0	0	0
DEBOND	12	0.4	7	0.2
ASPHALT PATCH	0	0	0	0
CONCRETE PATCH	0	0	0	0
TOTAL DEFECTS	12	0.4	7	0.2

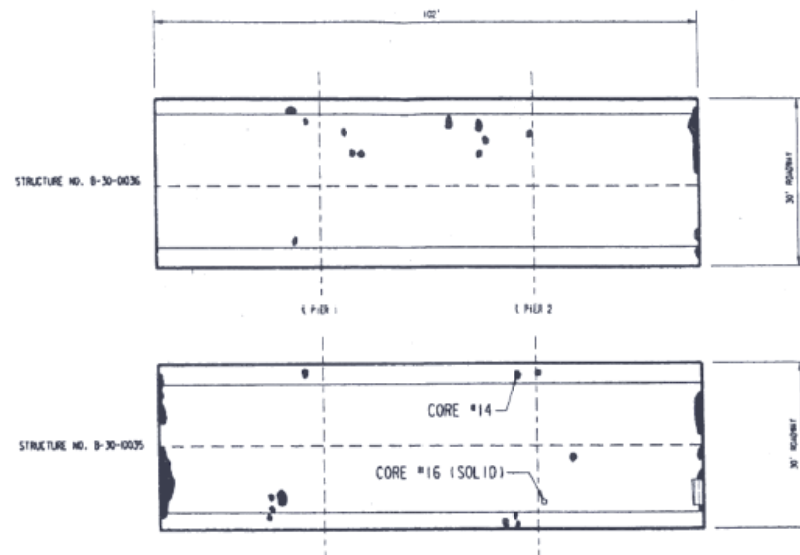
INSPECTION DATE: 6/1995

The results in 1995 showed that the total defects had increased approximately five times between 1990 and 1995 for both Structures (See Table 1 & Appendix D).

ST. NO. B-30-0035		ST. NO. B-30-0036	
DESCRIPTION	QUANTITY (SQ. FT.)	%	QUANTITY (SQ. FT.)
TOTAL AREA	3060		3060
SHADE/DEBRIS	0		0
TOTAL AREA INSPECTED	3060		3060
DELAMINATION	63	2.1	31
SPALL	0	0	0
DEBRID	0	0	0
ASPHALT PATCH	0	0	0
CONCRETE PATCH	10	0.3	0
TOTAL DEFECTS	73	2.4	31

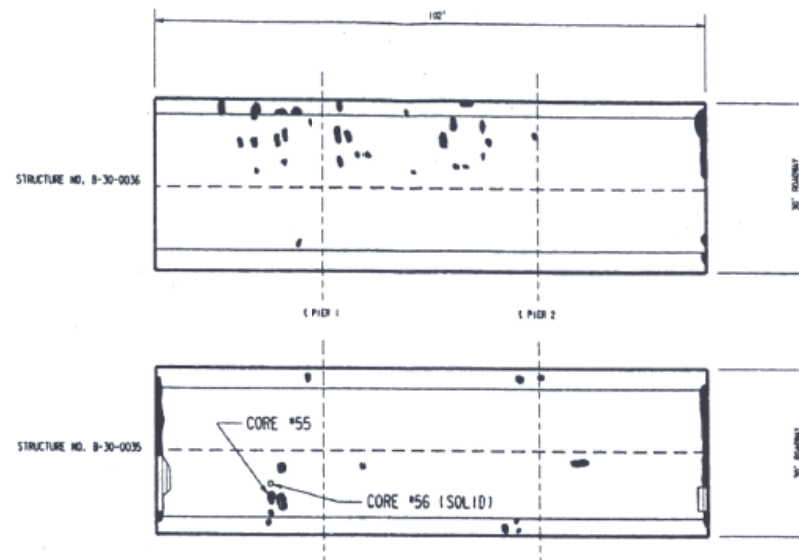
INSPECTION DATE: 6/1997

There was minimal difference in total defects for B-30-35 from the 1995 inspection. The total defect for B-30-36 was doubled from 1995, but was still minimal.

DESCRIPTION	ST. NO. B-30-0035		ST. NO. B-30-0036	
	QUANTITY (SQ. FT.)	%	QUANTITY (SQ. FT.)	%
TOTAL AREA	3060		3060	
SHADE/DEBRIS	0		0	
TOTAL AREA INSPECTED	3060		3060	
DELAMINATION	62	2.0	62	2.0
SPALL	0	0	0	0
DEBOND	0	0	0	0
ASPHALT PATCH	0	0	0	0
CONCRETE PATCH	28	0.9	0	0
TOTAL DEFECTS	90	2.9	62	2.0

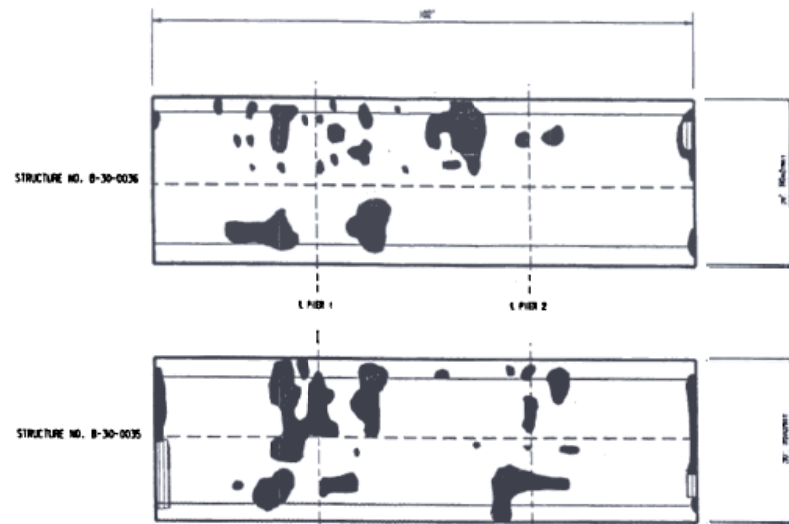
INSPECTION DATE: 6/1999

The total defects for both structures had increased substantially over the two-year period, since the 1997 survey. The total defects for B-30-35 had increased from 2.9 percent to 16.4 percent and from 2 percent to 11.8 percent for B-30-36 (See Table 1, & Appendix D).

ST. NO. B-30-0035		ST. NO. B-30-0036	
DESCRIPTION	QUANTITY (SOL.FT ²)	%	QUANTITY (SOL.FT ²)	%
TOTAL AREA	3060		3060	
SHADE/DEBRIS	0		0	
TOTAL AREA INSPECTED	3060		3060	
DELAMINATION	464	15.2	250	11.4
SPALL	0	0	0	0
DEBOND	0	0	0	0
ASPHALT PATCH	0	0	0	0
CONCRETE PATCH	37	1.2	11	0.4
TOTAL DEFECTS	501	16.4	261	11.8
